E-470 Public Highway Authority

# 2025 Annual Certification

# 2025 E-470 Annual Certification Report

Prepared for the E-470 Public Highway Authority by Short Elliott Hendrickson Inc. (SEH)

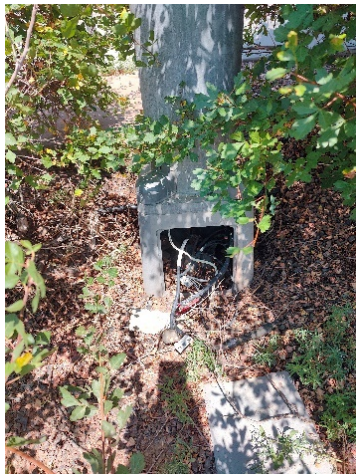
**Figure 2-1 – Open access panel with wires exposed, SB Chambers Off Ramp**

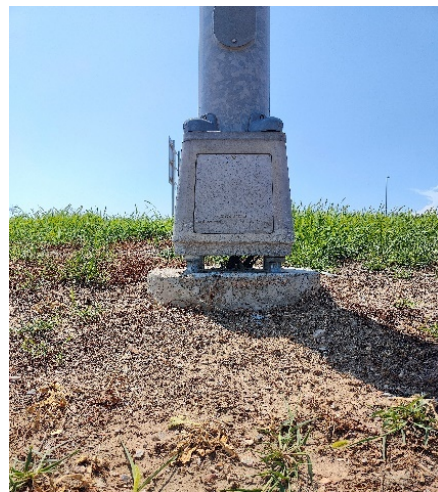
A random selection of 149 lights (~10%) were inspected for bolt tightness, weld conditions, rust, cracks, flaking paint, and erosion around the poles. **The detailed light inspection confirmed the lights are in excellent operating condition with the average individual light achieving a score of 98.59.** We found no loose anchor bolts during inspection. Rust, weld, or paint issues were present on 26 light poles at the time of inspection, these figures included open hatch panels. An example of this are depicted in **Figure 2-1** below. 45 poles were noted to be missing bolt caps. One pole was found to have an open air gap between the pole foundation and the base; this is shown in **Figure 2-2** below.

**Figure 2-2 – Pole with observed gap between foundation and base**

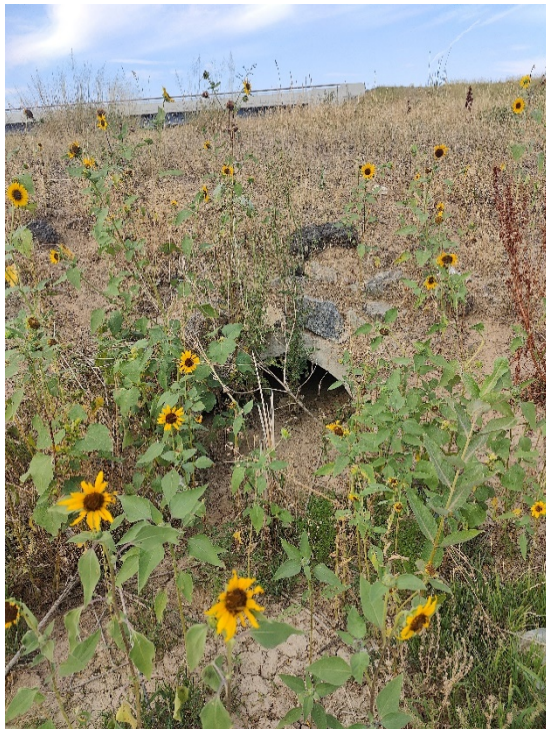
One RCP (**Figure 2-3 and 2-4** below) was observed with sediment and trash blocking more than 50% of the pipe capacity. **Figure 2-5** shows early warning signs of tumbleweed piling up at the outlet of a CBC just south of 112<sup>th</sup> Ave. **Figure 2-6** shows foliage and undergrowth taking place at the inlet of CBC around mile marker 7.5. **Figure 2-7** showcased extensive tumbleweed blocks at the inlet of a culvert in the NB shoulder just south of SH 30. **Overall, the box culverts are in excellent condition with an average score of 99.60. The reinforced concrete pipes were also in the excellent condition range with an average of 95.27. Both drainage assets combined averaged a 97.43.**

**Figure 2-3 – Culvert with significant dirt build-up clogging the inlet just north of E Quincy Ave**

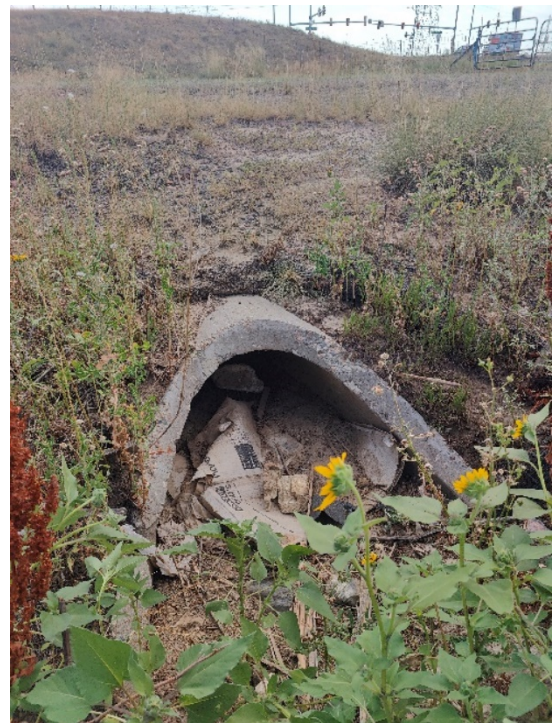
**Figure 2-4 – Outlet of the culvert in Figure 2-3, displaying sediment and trash blockage**

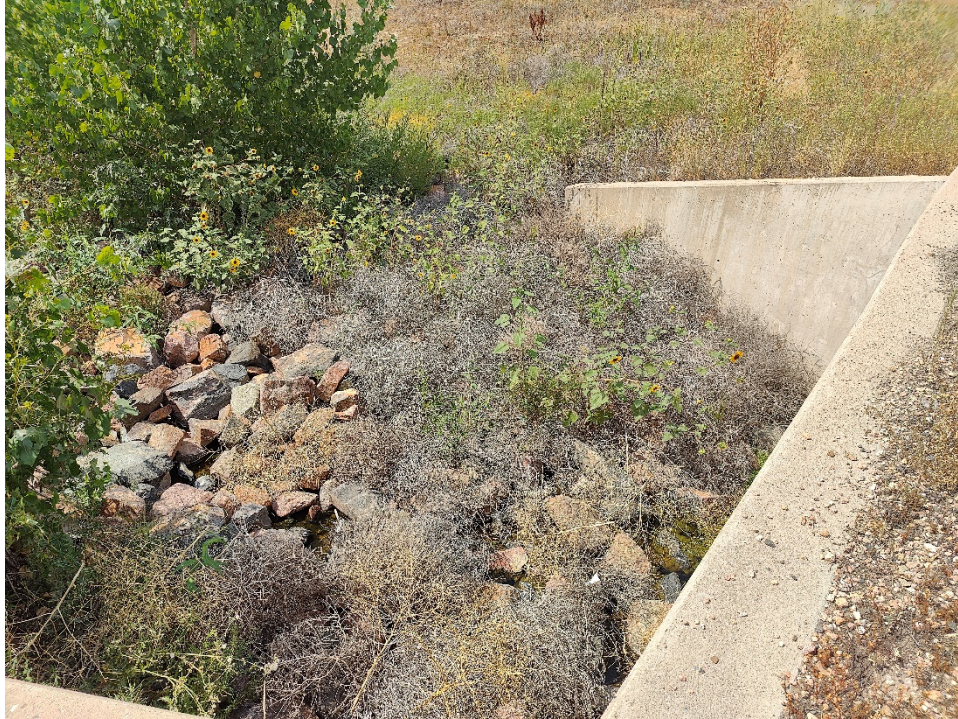
**Figure 2-5 – Start of tumbleweed collection at outlet of CBC north of Tower Road**

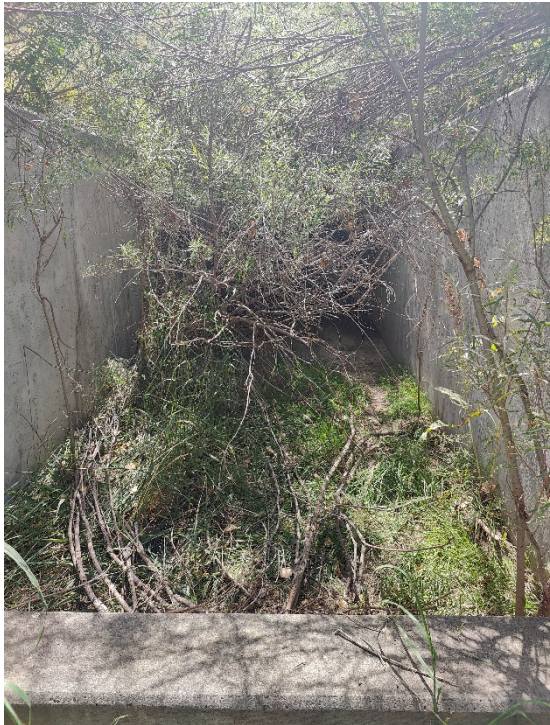
**Figure 2-6 – CBC at MP 7.25 with significant foliage and overgrowth at the inlet**

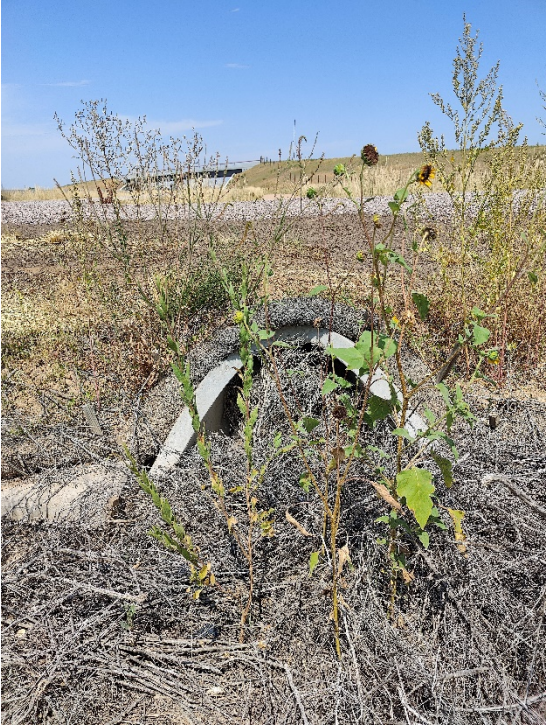
**Figure 2-7 – Culvert south of SH 30 with significant tumbleweed blockage at inlet**

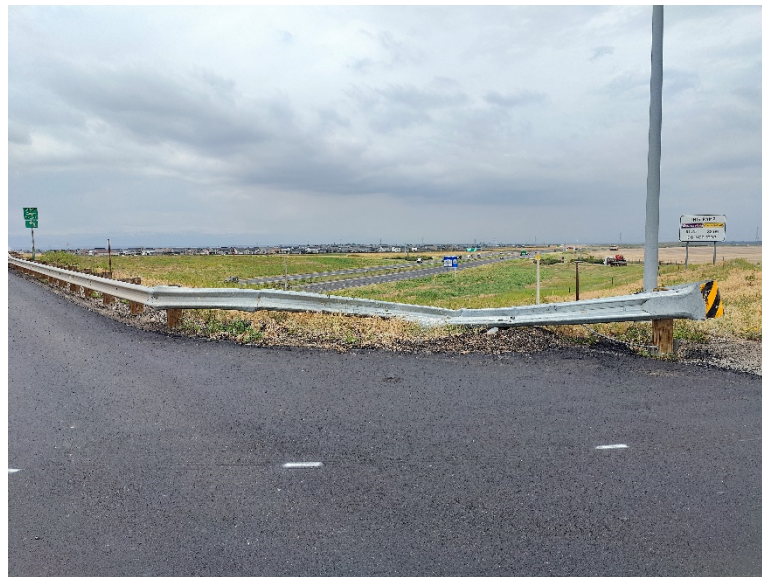
**Figure 2-8 – Collision damage to guardrail at 96<sup>th</sup> Ave NB ramp**

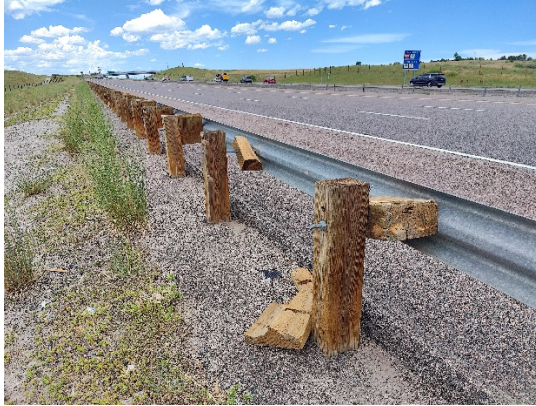
**Figure 2-9 – Broken wooden posts (typ.)**

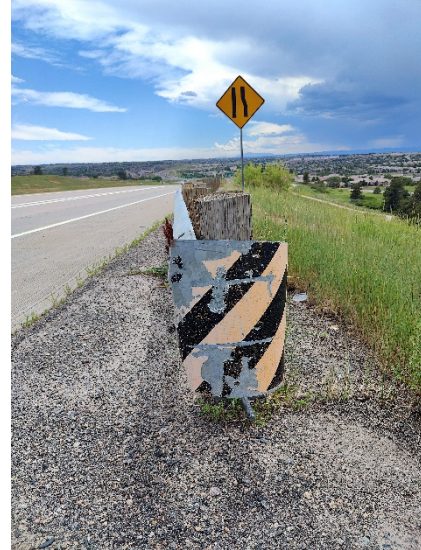
**Figure 2-10 – Scraped and fading marker paint on guardrail along SB Smoky Hill On Ramp**

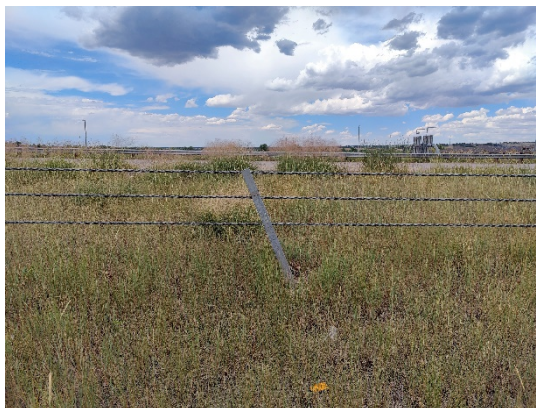
**Figure 2-11 – Bent post (typ.)**

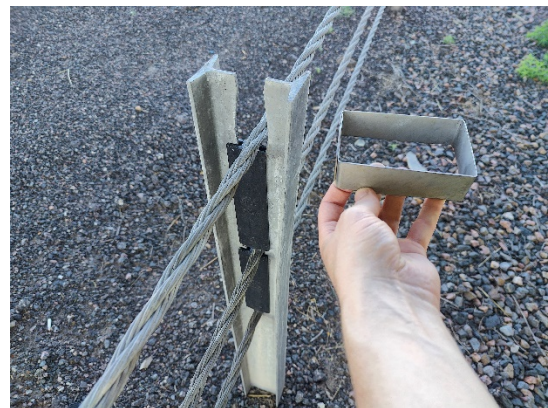
**Figure 2-12 – Broken steel rings (typ.)**

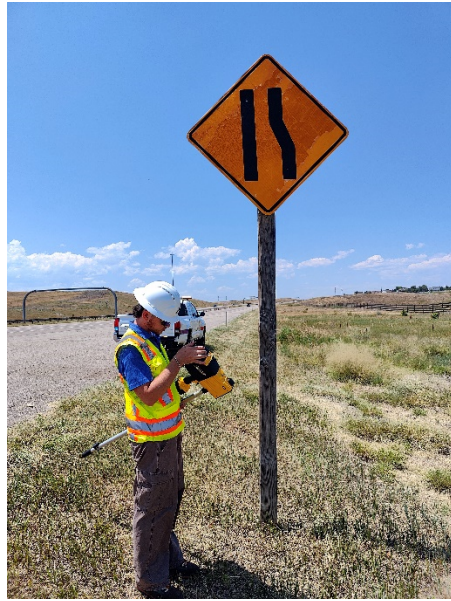
**Figure 2-13** on the following page a sun-damaged sign near Toll Plaza E. The protective coatings were cracked and the paint was chipping and faded in color. **Figure 2-14** showcases a hospital sign near Buckley Road which is bent significantly from a vehicle collision.

**Figure 2-13 – Faded peeling sign near TPE**

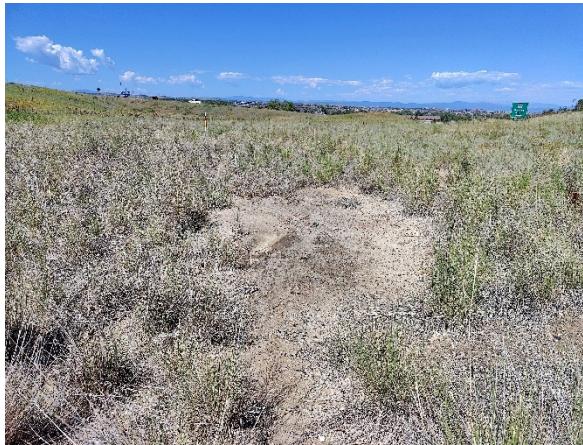
**Figure 2-15** displays an example of the typical patchiness of grass coverage observed at three separate locations. No major erosion or Prairie Dog damage was observed in the areas randomly selected.

**Figure 2-15 – Bare patches amongst grass coverage (typ.)**

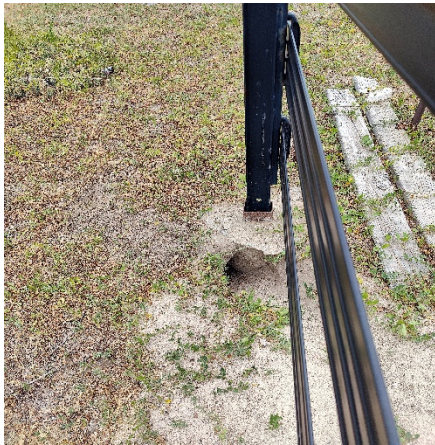
Figure 2-16 – Prairie Dog tunnel at snow fence post foundation

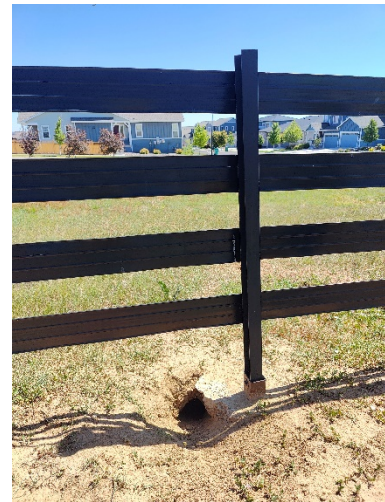
Figure 2-17 – Another Prairie Dog tunnel at snow fence post foundation

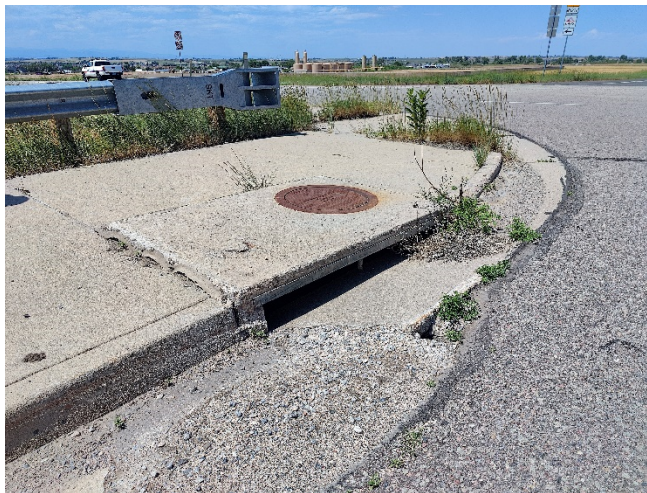
One location of note was the EP at the NW corner of Colorado Blvd; **Figure 2-18** below showcases settling of the concrete which is creating a hole at the edge of pavement. **The overall condition of Embankment Protectors was found to be excellent, with an average score of 91.07.**

Figure 2-18 – Settling and concrete warping at EP inlet at Colorado Blvd. Exit

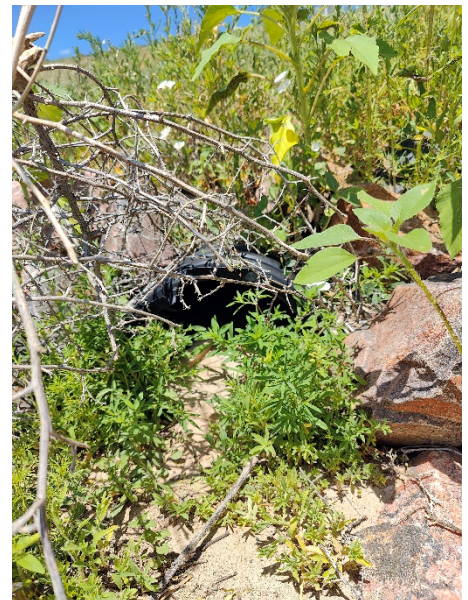
Figure 2-19 – Heavily blocked and overgrown EP outlet at 104 Ave.
